**Municipality of Shuniah
Designated Substance Survey
McTavish Recreation Centre, Pearl, ON**

December 22, 2009

**Appendix A:
Photographs**

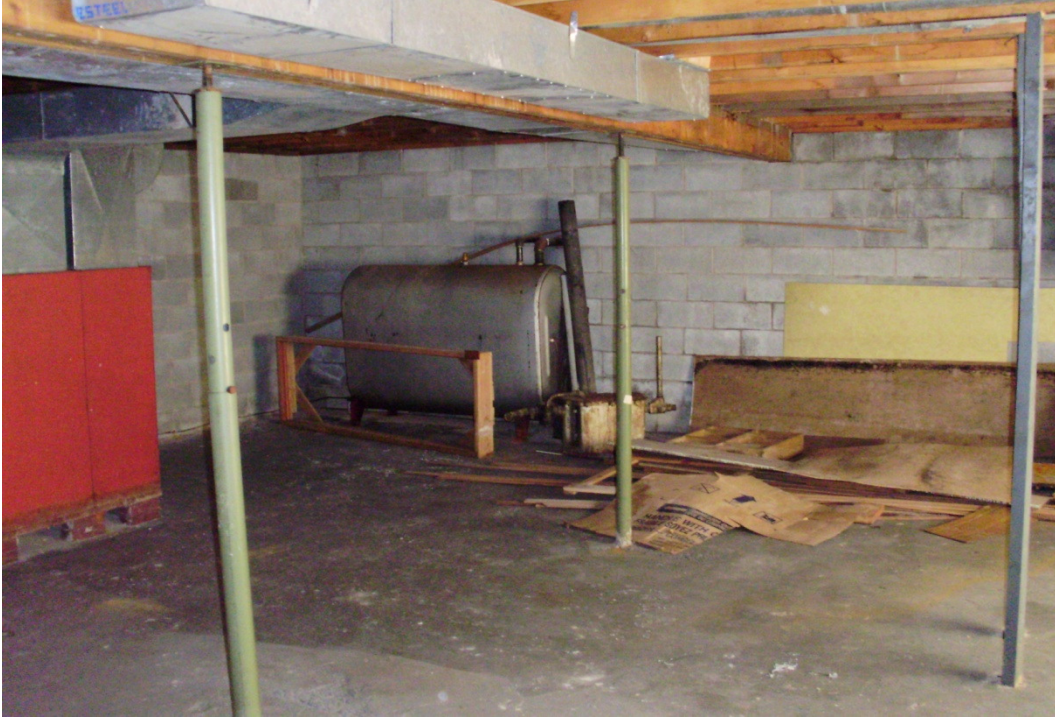
Hazardous materials observed to be present in the building consist of some household cleaners located in the janitor's closet in Room 10, a freezer located in Room 8 and a fridge located in Room 17 that may contain Freon and a fuel oil tank in the basement that appears to be empty but may contain residual fuel oil.

Photo 1: Basement, 900 L fuel tank in NE corner. Appears to be empty.

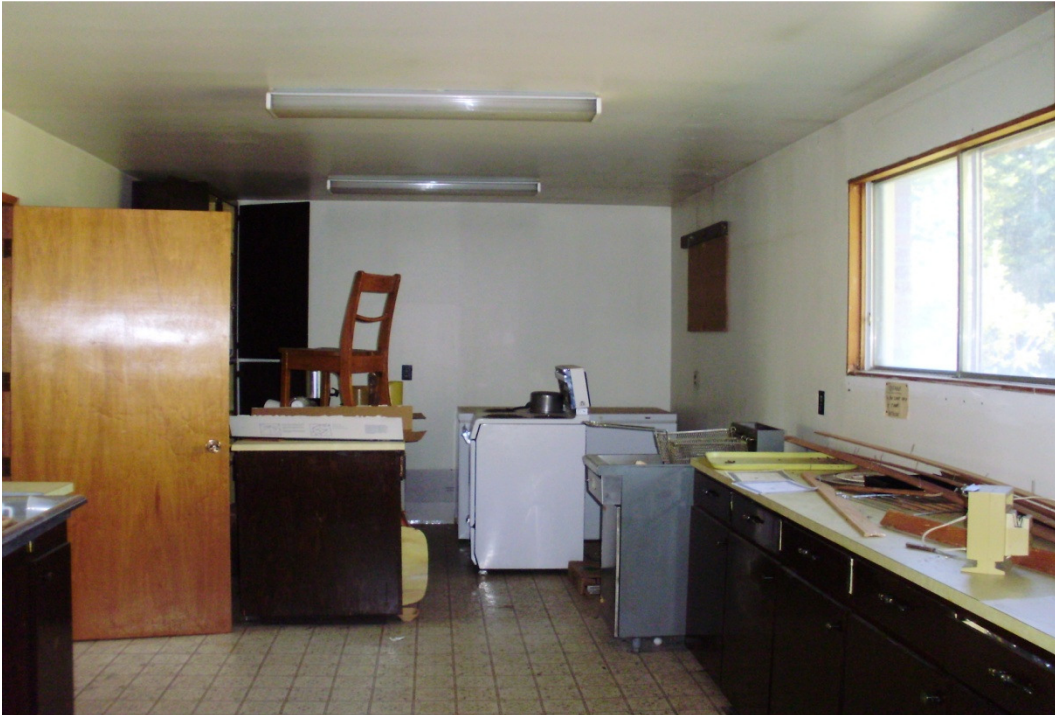
ACM was found in three different building materials within the recreation centre: the drywall compound in the older section of the building, the vinyl floor tile in room 4, room 5 and room 8, and the pipe insulation in the boiler room.

Photo 2: Room No.8, AC floor tile and possible freon containing freezer.

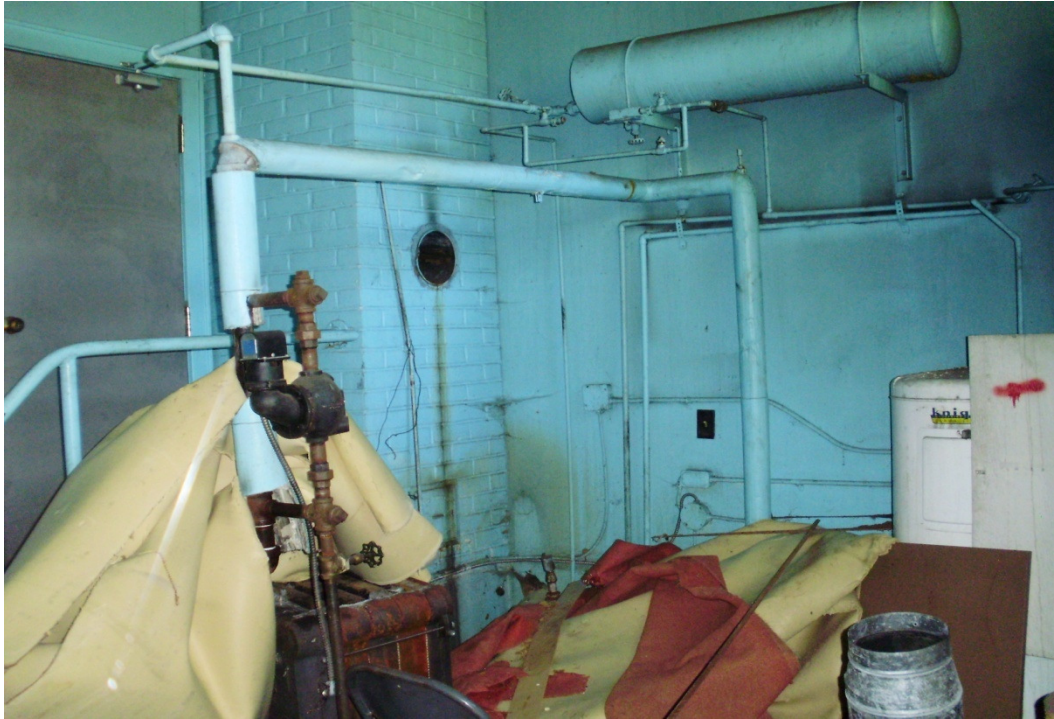
Photo 3: Room No. 18, AC air cell pipe insulation. Approximately 20 linear meters and 2 elbows. Unknown if it continues under building.

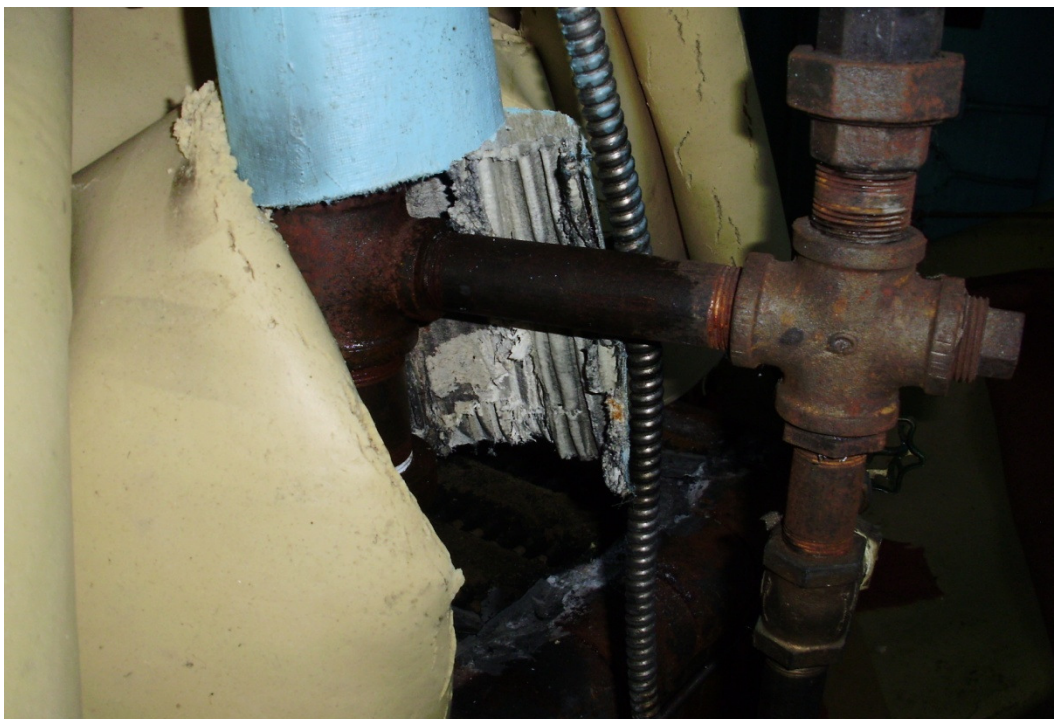
Photo 4: Room No. 18, AC air cell pipe insulation referenced in in the previous photo.

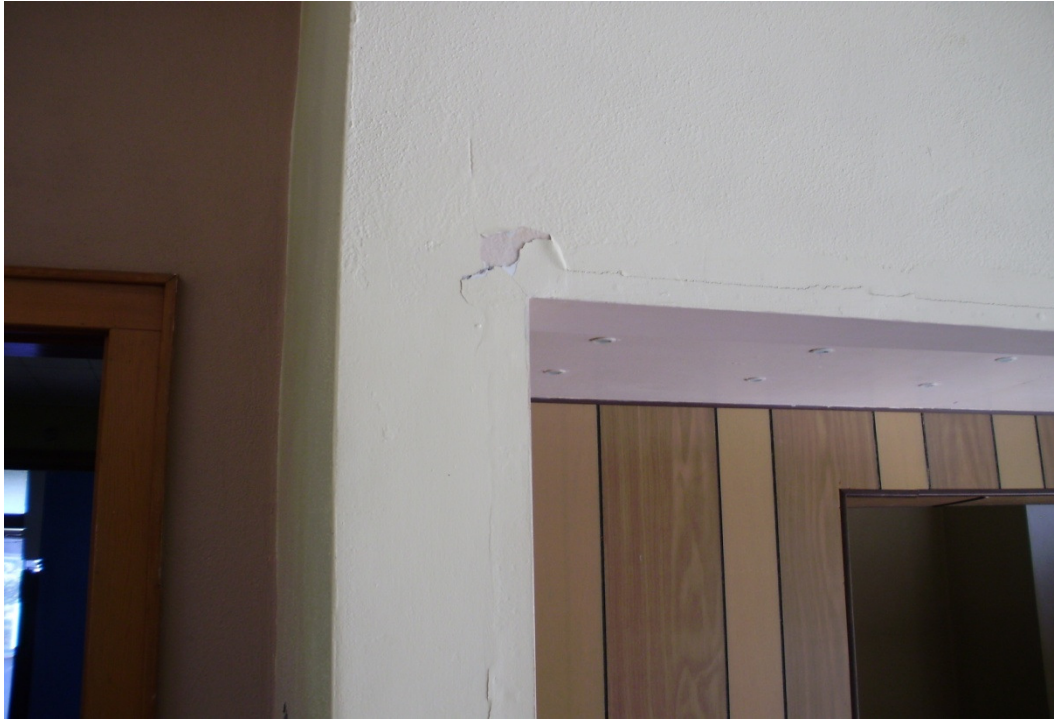
**Photo 5: Room No. 9, AC mud joint compound (MJC) in the original building.
Deem all MJC in this portion of the building to contain asbestos.**

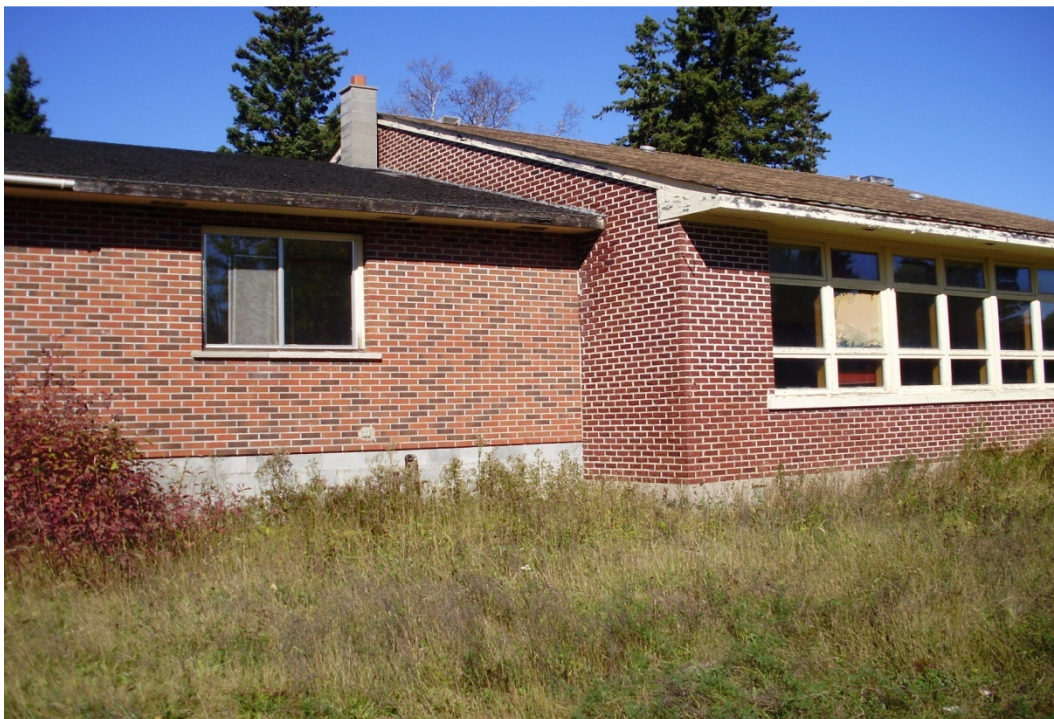
Photo 6: Exterior looking NW, older construction to the right and newer construction to the left. .
